| <b>Project Name:</b><br>Gold King Mine | <b>Site Location:</b><br>Silverton, San Juan County, Colorado | <b>Project No.</b><br>0001/1408-01 |

## PHOTOGRAPH LOG

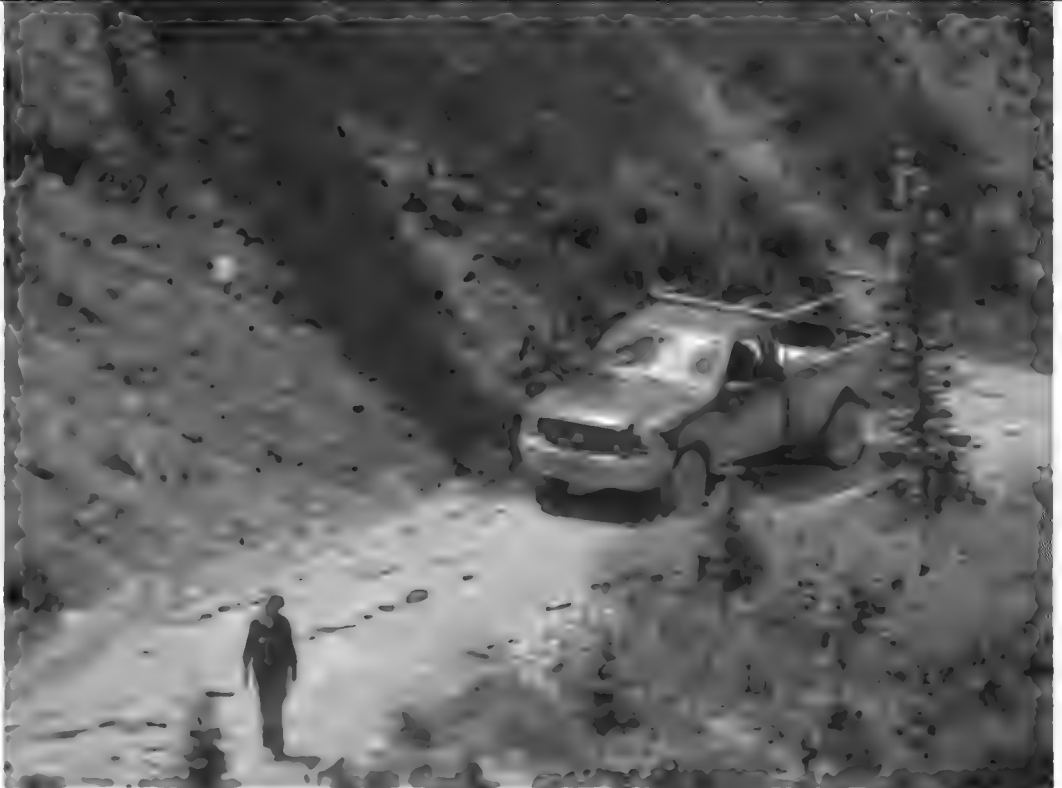
| <b>Photo No</b><br>41 | <b>Date:</b><br>08/05/2015 | |

| <b>Description:</b><br>Noted visitor to the site, unknown person, walked up to excavator at North Fork crossing and then back to vehicle. | | |

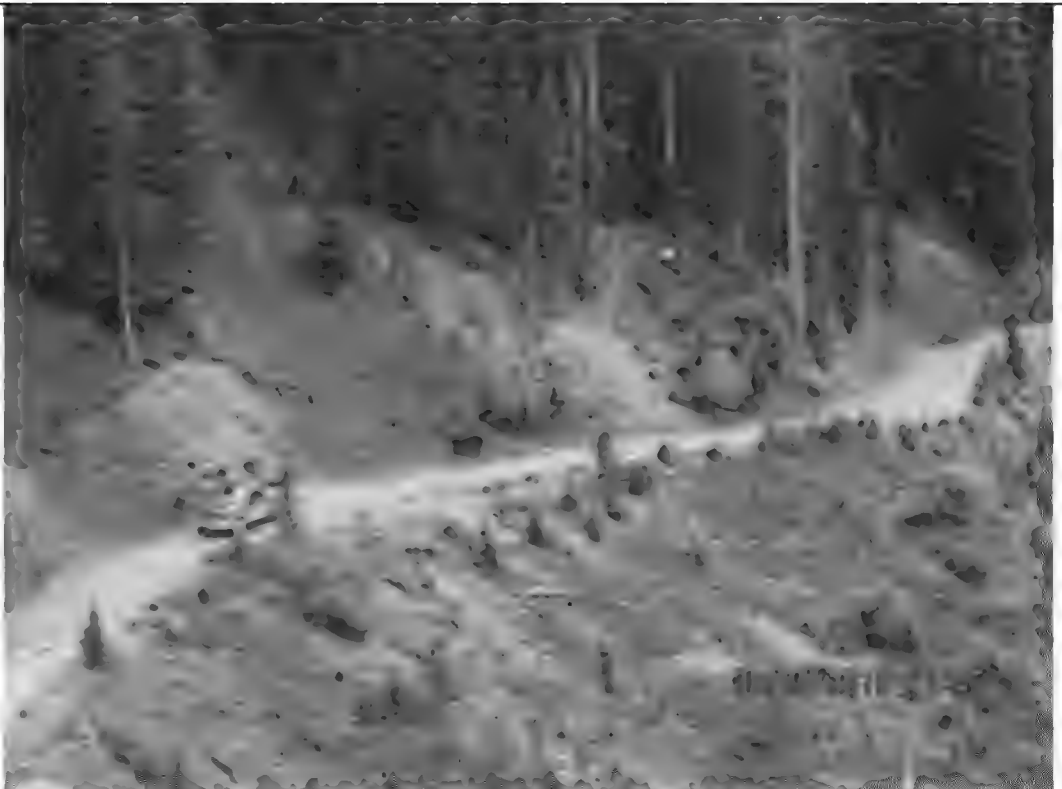
| <b>Photo No</b><br>42 | <b>Date:</b><br>08/05/2015 | |

| <b>Description:</b><br>Visitor leaving | | |

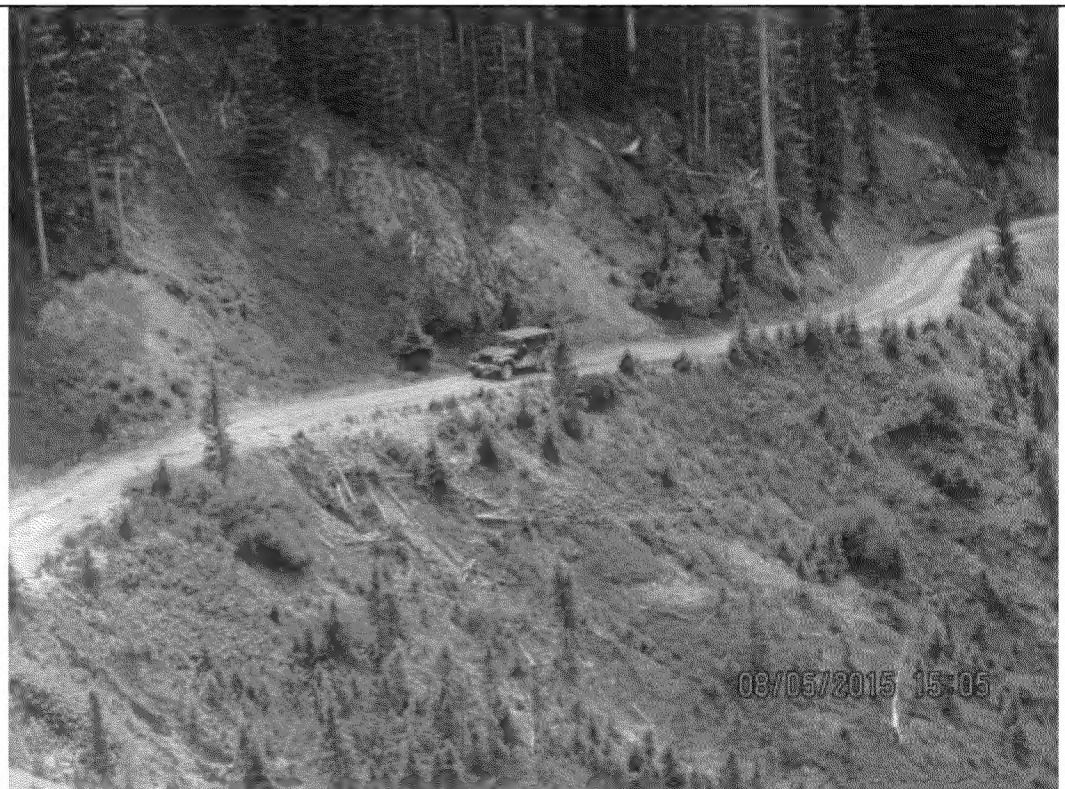
**Photo No.**  
**50**

DRMS arrives back on site, had visited the site around 0930 to check on progress of investigation, left approximately 1030, prior to blowout.

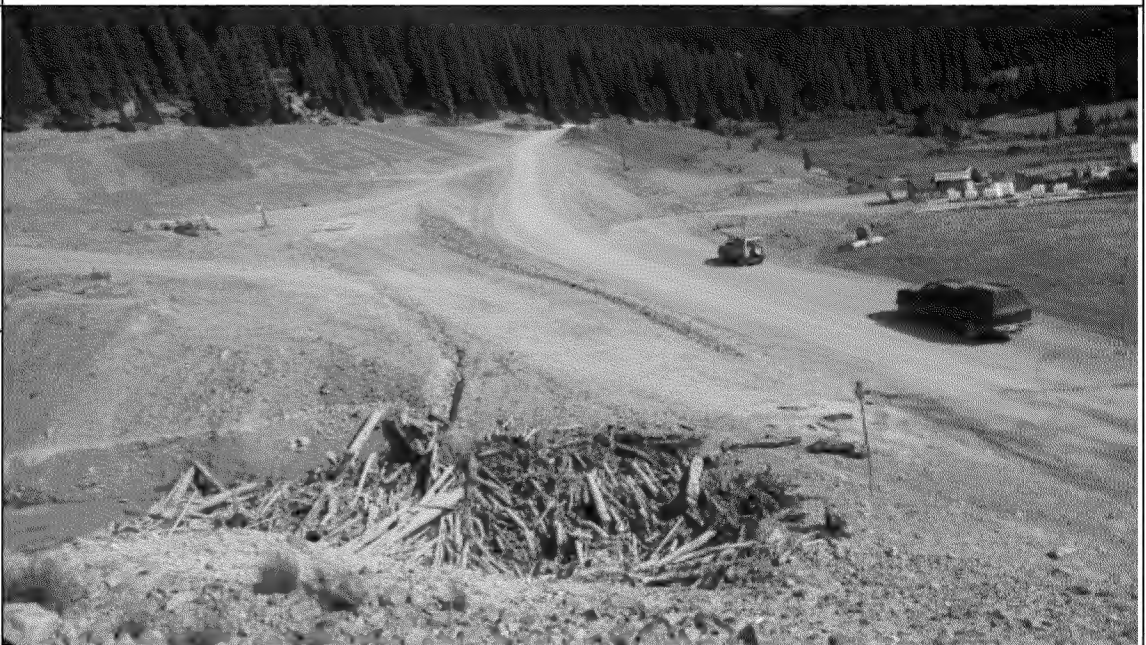
| <b>Photo No.</b><br><b>54</b> | <b>Date:</b><br>08/05/2015 | |

| <b>Description:</b><br><br>Cement Creek crossing at Gladstone. | | |
